CONCRETE REPAIR

Royal Floridian Resort

Ormand Beach, FL

Submitted by ConTech Construction, LLC

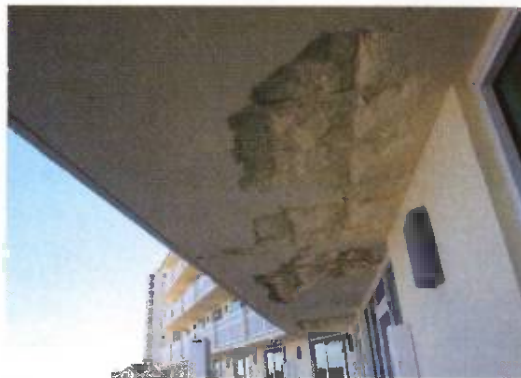
The balconies had visible underside and topside spalling throughout. Reinforcing steel was exposed in many large areas and was obviously corroded. Water had been penetrating into the units during typical rainstorms. Cracks were visible in balcony edges and at the base of columns. The underground garage suffered water leaching in, creating stalactites hanging from the ceiling, because the waterproofing membrane on the pool deck above had failed. The north and south ends of the structure had cracks and large areas of disbonded stucco. The air-conditioning units on the balconies had rusted and corroded, leaving piles of rust on the floors and orange streaks running down the building. Pavers on the pool deck were efflorescing and discolored.

Severe underside spalling of balconies

Twenty jackhammers were used to remove the balconies to a line 24 in. (610 mm) inside each unit. The broken concrete fell to the balcony below, from which it was then deposited into small dumpsters

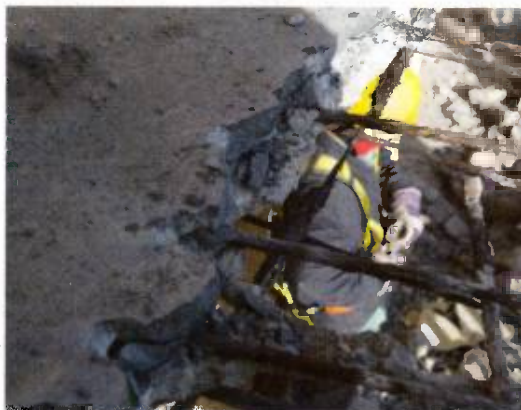
Reinforcing steel was extensively corroded

indicated a pH below 9 at the base of the spalls. Concrete and steel damage was extensive on the balconies and walkways. Moderate damage was observed on the columns, seawall garage, and front porte cochere ceiling. Reinforcing steel corrosion was common and generally severe under and along the aluminum storefronts and the concrete spalling extended into the unit interiors. Extensive damage was caused by the aluminum electrical conduit that was in contact with the reinforcing steel. The steel corrosion in these areas was caused by a reaction caused by the galvanic voltage difference between the aluminum (-0.604 volts) and ferric steel (-0.207 volts) embedded in a conductive electrolytic solution-wet concrete.

and transported to large dumpsters on the ground. The existing steel was cut out and removed, except for the lap length, which was sandblasted and augmented with additional bars where it had lost 30% of its cross-sectional area. All the old concrete and steel was recycled. The speed of removal was striking—2400 linear ft (731.5 linear m) of balcony was removed in 3 weeks.

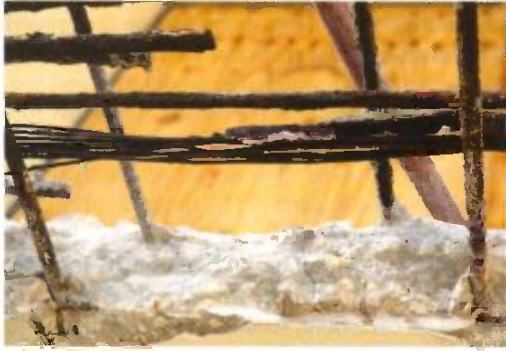
Close-up view of corroded reinforcing steel

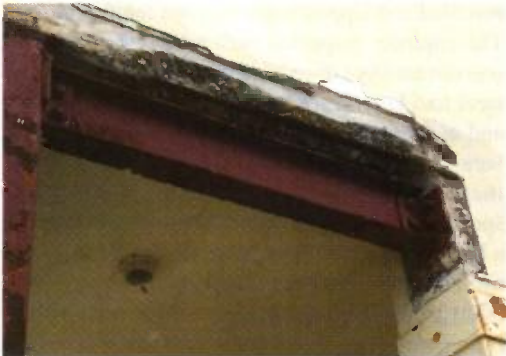
Corroded beams and columns were not capable of supporting loads much longer

The plan review showed a disturbing item. The north and south ends were originally designed to be 5 ft (1.5 m) cantilevered elevated slabs, but the top reinforcing had been left out of all these cantilevered areas back in the 1970s during the original concrete placement. Much cracking followed, and the steel beams and columns were added soon after the problem had been discovered. These beams and columns were now corroded and not capable of supporting the loads much longer.

Engineered shoring with needle beams was installed in preparation of removing and replacing the structural steel on the cantilevered ends of the building. This was the most challenging and daunting part of the project. A failure here could be catastrophic.

The contractor excavated around the existing footings, dowelled and epoxied new reinforcing, and poured the enlarged and new footings. The replacement of the structural steel beams and columns went exactly as planned, with no movement or settlement of the building when the supports were removed.

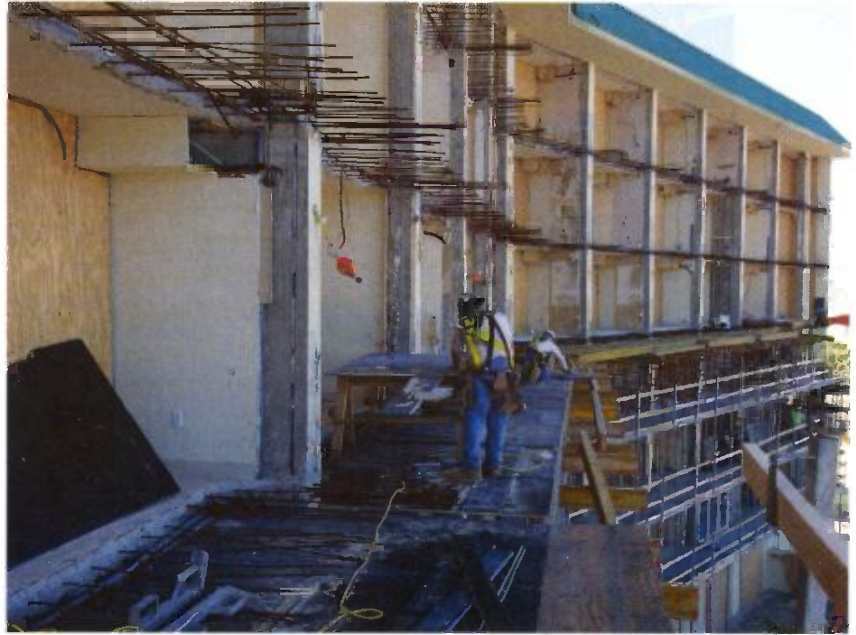
Work proceeding on balconies

The rebuild forming process started from the second floor to the seventh. The formwork was reused on each floor, reducing cost and increasing efficiency. As each 200 linear ft (61 linear m) section of decking was completed, new steel was installed and lapped to the cleaned reinforcing bar. The engineer inspected each area before the steel was covered by concrete. In many areas, the existing steel had been placed irregularly, both in spacing and in the height of the concrete. Many additional bars were drilled and epoxied into place to correct these deficiencies. A corrosion inhibitor was sprayed on the existing concrete to avoid creating a battery effect with the differential between the old and new concrete. The new concrete was a 5000 psi (34.5 MPa) concrete with a water-cement ratio (w/c) of 0.40. All slabs were finished with a light broom to allow for good adherence with coatings that would be applied later.

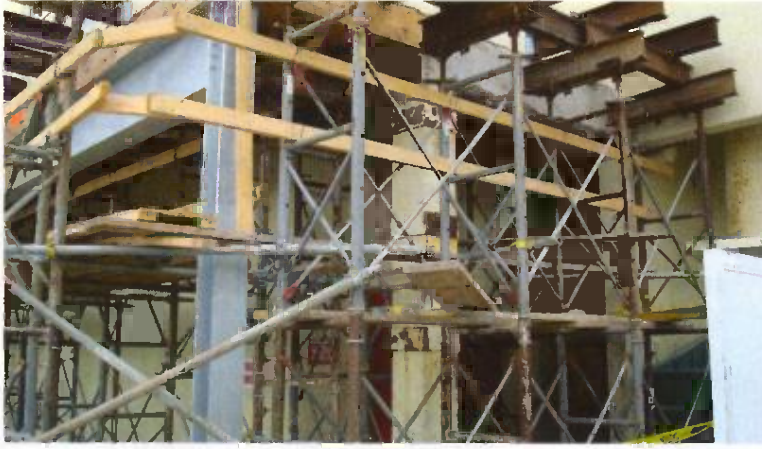
Replacement structural steel columns and beams

It was in the beginning of the structural steel replacement that another obstacle presented itself. It was discovered that when the beams and columns were added back in the 1970s, they were placed on footings that were grossly undersized for the loads imposed by the seven-floor structure. Several of the columns had no footing at all, but instead were resting on the original concrete pavement and concrete stairway. The adjacent concrete columns had severe cracking and bulging as the load shifted to these columns from the steel columns. It appeared that the containment steel ties were failing. To fix the problem, the engineer designed enlarged footings and new footings as required. The existing concrete columns would be removed and enlarged as well.

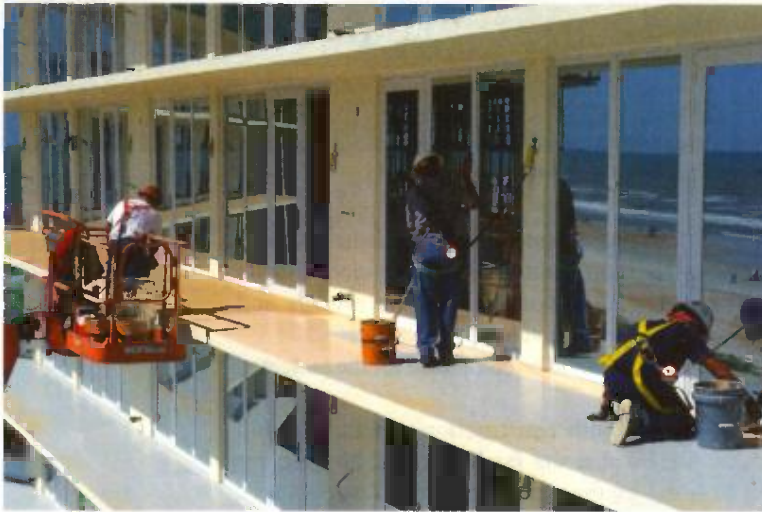
Coating being applied to new balconies

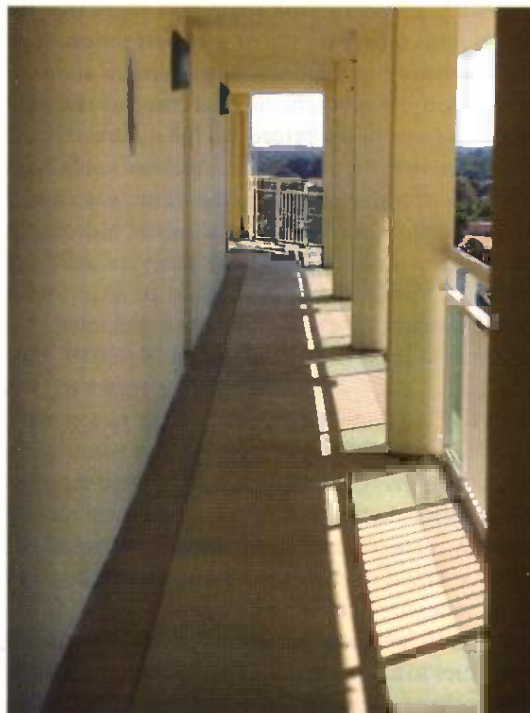
Finished balcony with new railing
