CONCRETE REPAIR

Royal Floridian Resort

Ormand Beach, FL

Submitted by ConTech Construction, LLC

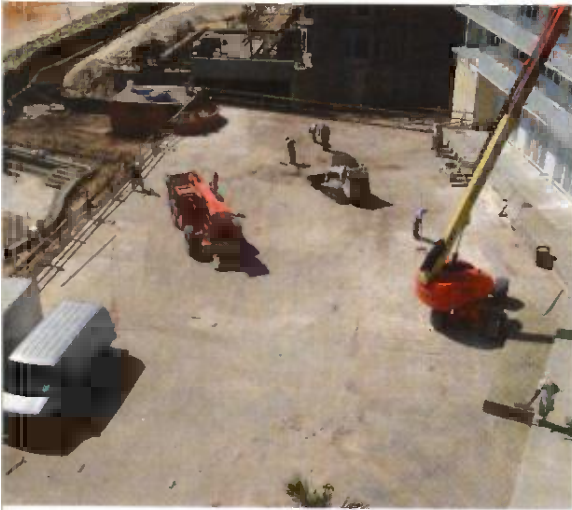
Work proceeding on new deck and pool area

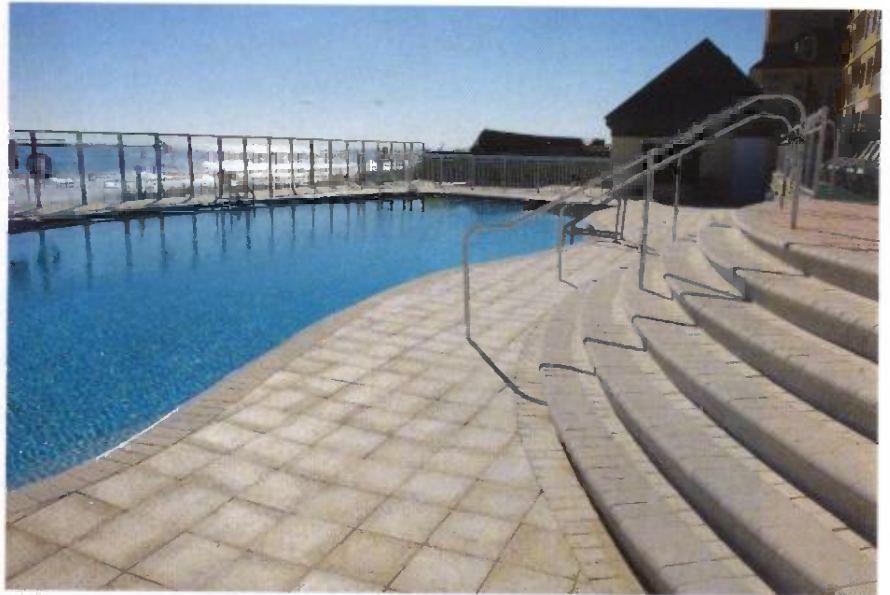
New deck and pool area

existing deck had an interesting layout of paving and curvilinear planters, the pavers were outdated, and the raised planters were difficult to maintain and allowed water infiltration into the garage below. The architect used this opportunity to delete the existing planters and create additional deck space with a circular paver pattern with a palette of colors that accentuated the building's new color scheme. The new deck and pool renovation creates a spectacular foreground for the ocean view from the unit balconies above.

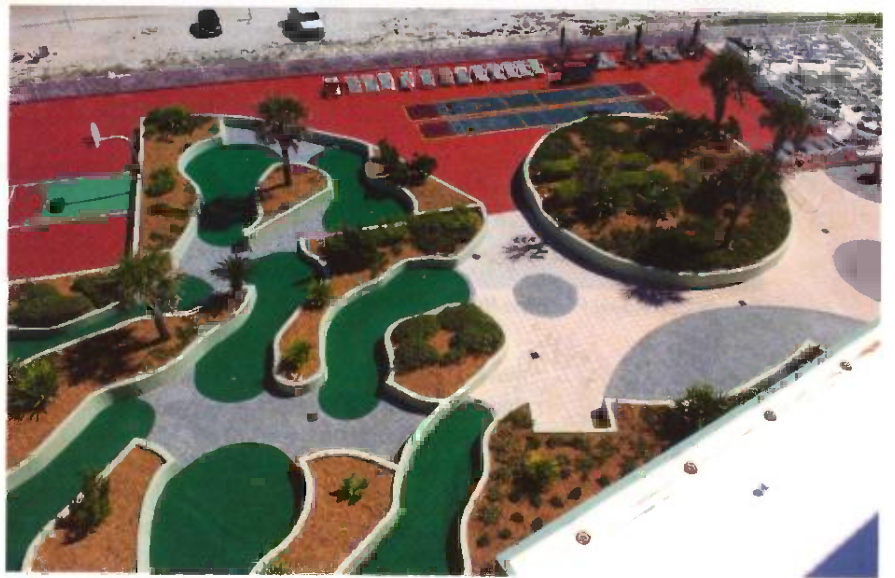
New recreation deck area

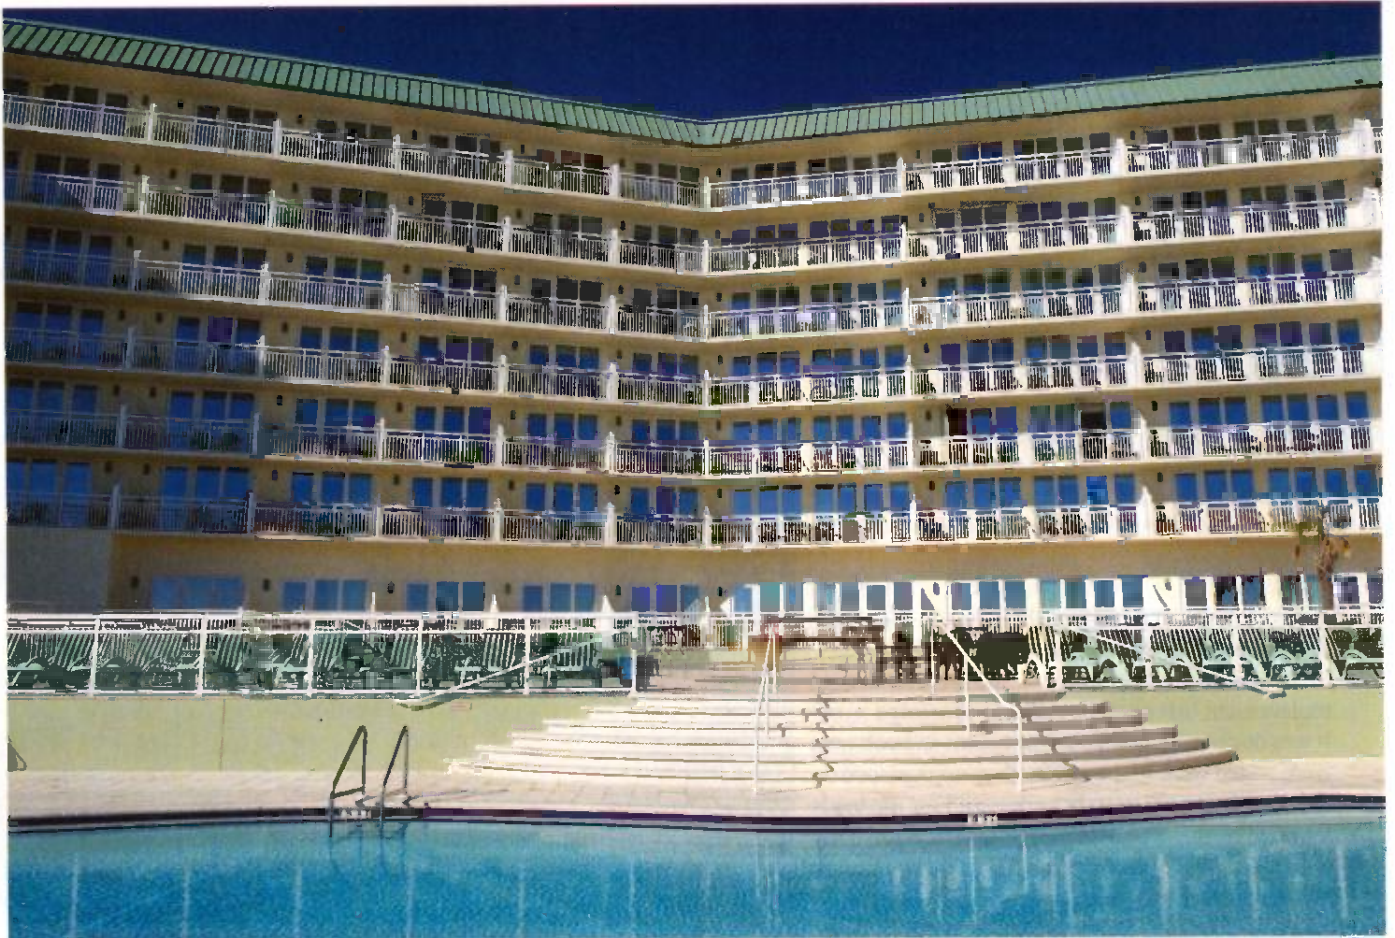
Completed Royal Floridian Resort renovation

these surprises included standard picket railings that were replaced with a modern-style guardrail with glass inserts; waterproof deck walkways with intricate paver details; a new energetic color palette throughout the property; modern window systems tinted the color of sea glass; and a complete renovation of the porte cochere entry, which included new lighting fixtures, cast-in-place stamped concrete ornamentation, and a sleek minimalist entryway free of the previous clutter.
